FINAL REPORT
STRUCTURAL INVESTIGATION

1845 - 1902 CAPITOL BUILDING

TALLAHASSEE, FLORIDA

3 MAY 1978

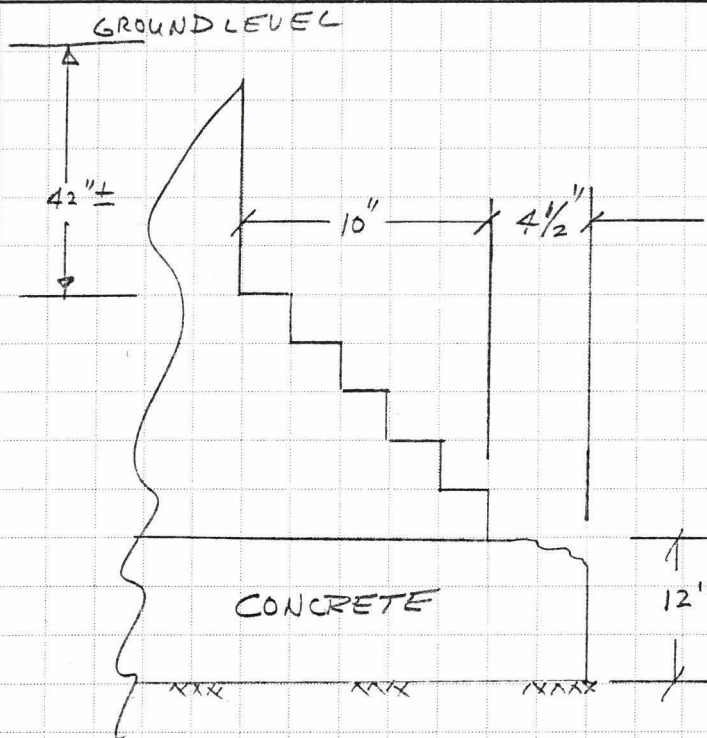
1

MORTAR & BRICK IN GOOD CONDITION - NO VISIBLE
CRACKING IN MORTAR, BRICK, OR CONCRETE

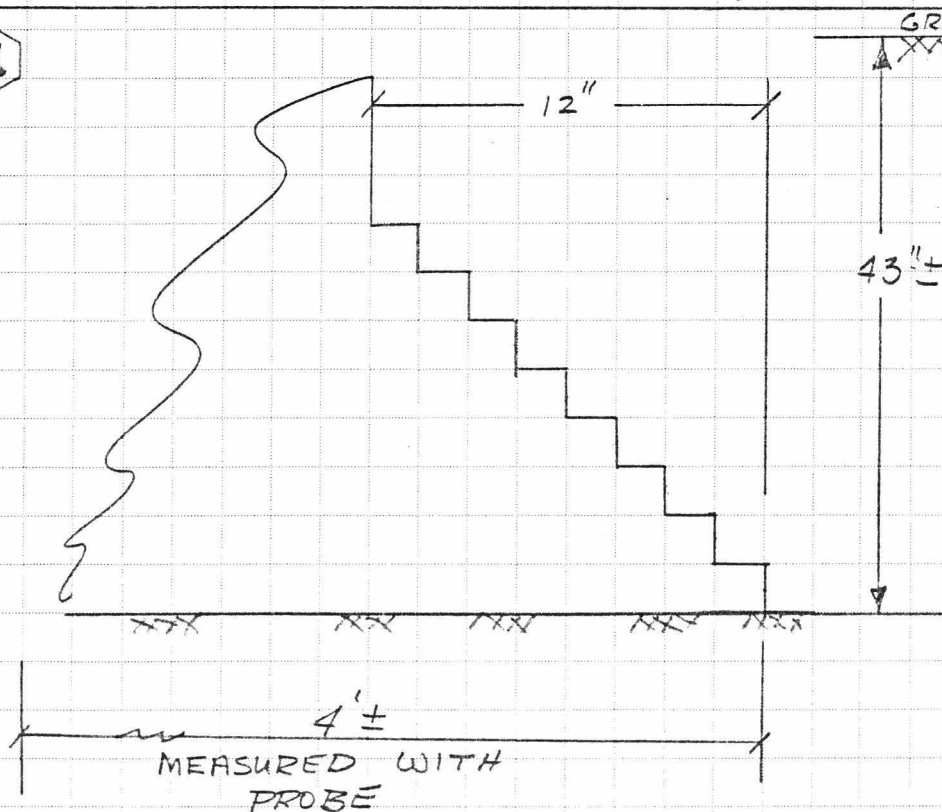
2

- 1) MORTAR IS LIKE WET SAND ON FOUNDATION,
- 2) BRICKS ARE IN FAIR COND.
- 3) BOTTOM LAYER OF BRICK ARE LAID CROSSWAYS (LENGTH OF BRICK PERPENDICULAR TO WALL)
- 4) NO VISIBLE CRACKING

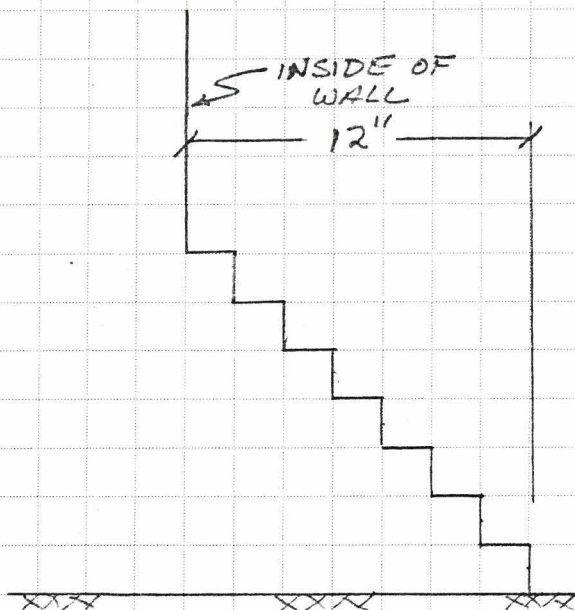
3

- 1) MORTAR IS SOFT.
BRICK CONDITION - FAIR
- 2) NO VISIBLE CRACKS
IN BRICK OR
MORTAR
- 3) BOTTOM LAYER
BRICK CROSSWAYS

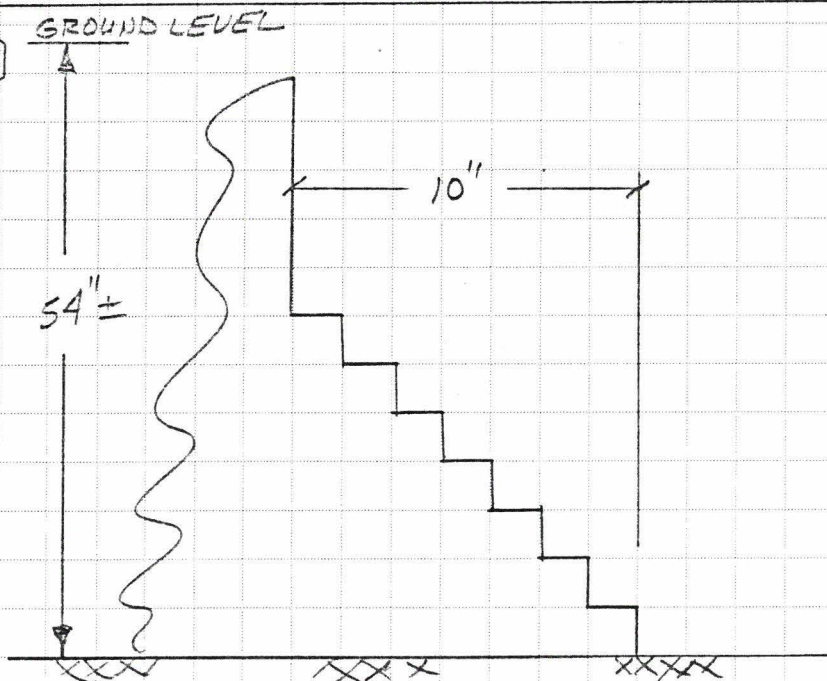
4

- 1) MORTAR IS SOFT
BRICKS IN FAIR
CONDITION
- 2) NO VISIBLE CRACKING

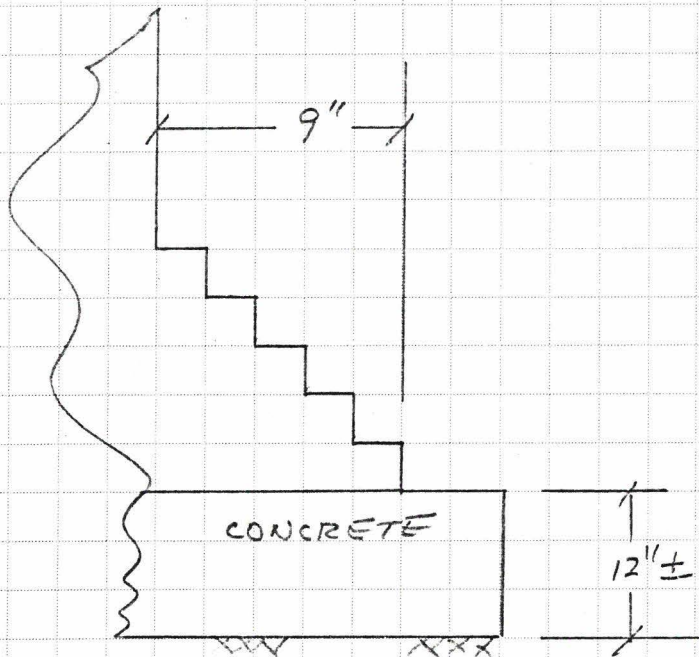
5

- 1) BRICK & MORTAR ARE IN GOOD CONDITION
- 2) NO VISIBLE CRACKING
- 3) CONCRETE APPEARS TO HAVE A SLAG AGGREGATE

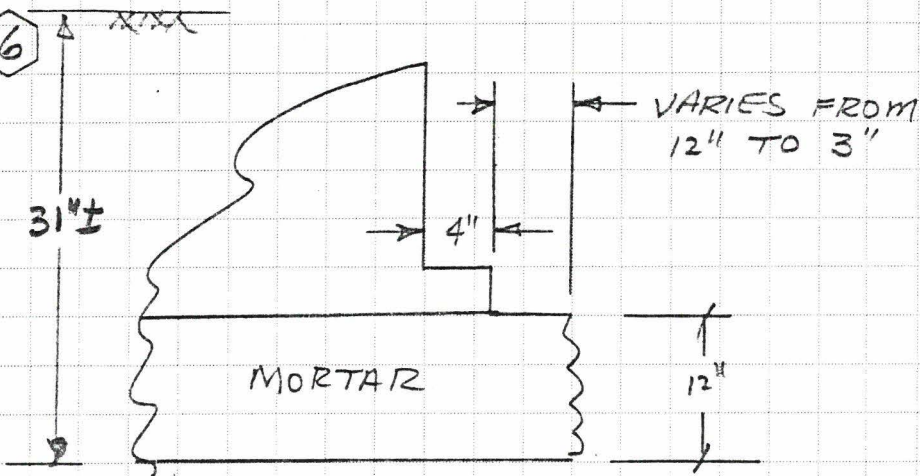
6

- 1) BRICK & MORTAR IN FAIR CONDITION
- 2) MORTAR/CONCRETE IN FOOTING VERY SOFT

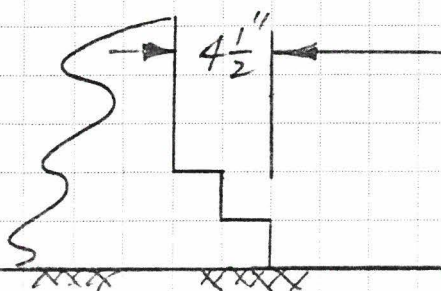
9

- 1) BRICK & MORTAR
FAIR - APPARENTLY
MOISTURE HAS
NOT BEEN AS
HIGH THIS LOC.

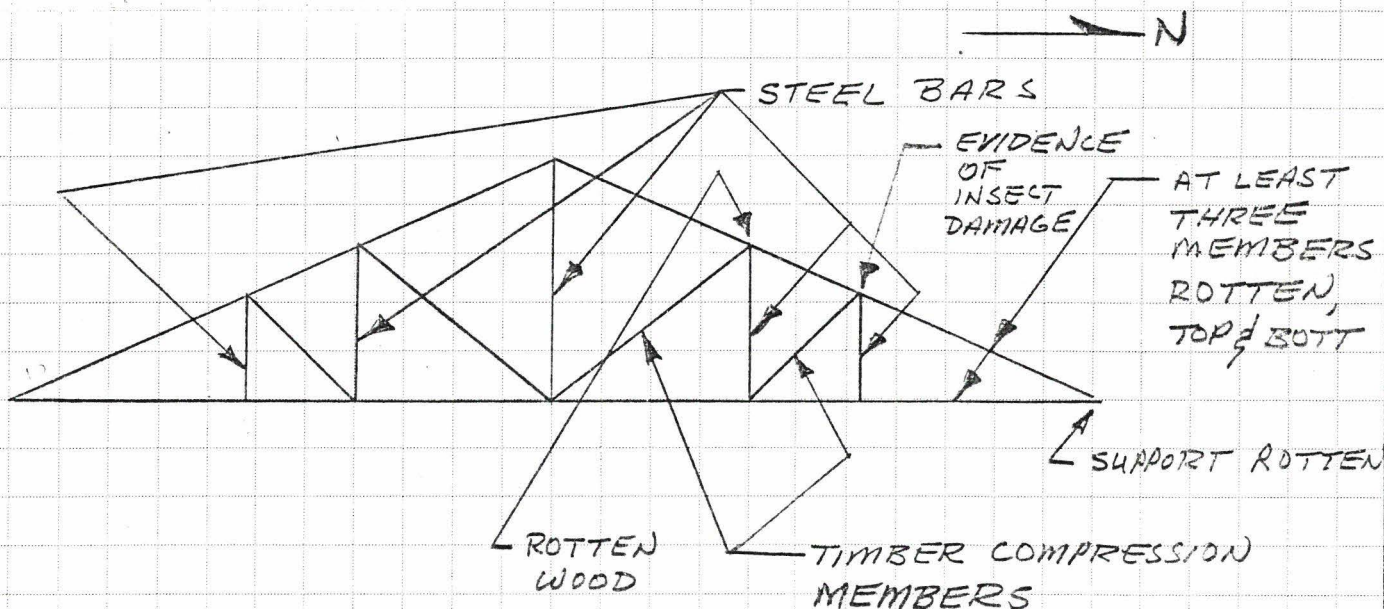
Dome area West side, main truss running North-South.

The main trusses supporting the dome framing and consequently the dome are the east and west trusses (span north-south). Of these two the west truss has lost at least 50% of its strength due to termite damage, stress reversals and deformation. The top and bottom chords are taking the stresses that normally would be carried by the diagonal compressive members. In addition, 40% of the cross sectional area of the bottom chord will no longer have any significant load carrying capability.

This particular truss has deteriorated to the point where it is in danger of collapse. Recommendations will be made in the next section for shoring to support this truss.

- 1) ALL COMPRESSION MEMBERS LOOSE
- 2) TRUSS IS SAGGING BADLY

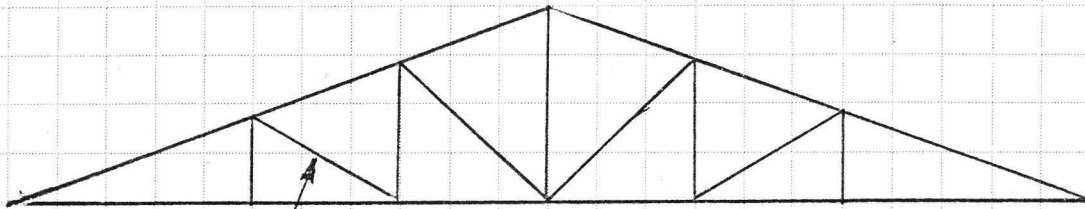
COMPRESSION
MEMBER
LOOSE

COMPRESSION JOINTS
HAVE BEEN SHIMMED

- 1) TIMBER IS IN GOOD CONDITION BUT TRUSS IS SAGGING BADLY.
- 2) TIMBER BEAM SUPPORTING BOTTOM OF STAIRS IN THIS AREA HAS BEEN DAMAGED BY INSECTS.

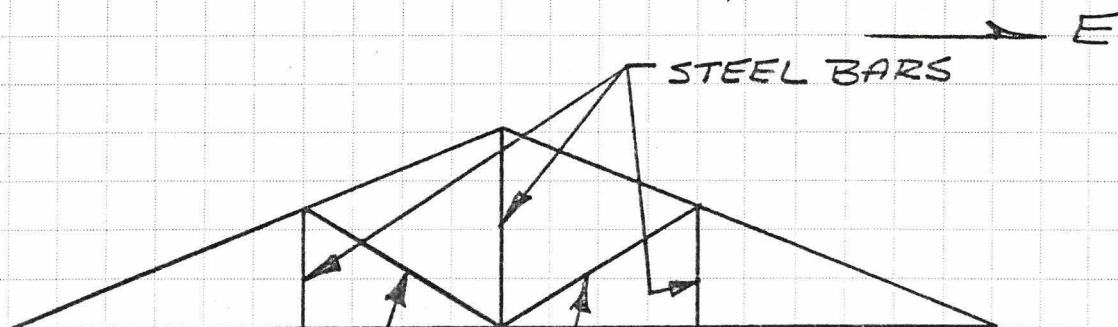
TRUSS RUNNING EAST-WEST ON SOUTH SIDE OF DOME

GAP BETWEEN TOP CHORD
& COMPRESSION MEMBERS

- 1) THIS TRUSS BEARS ON TOP CHORDS OF MAIN NORTH SOUTH TRUSSES
- 2) TIMBER APPEARS TO BE IN GOOD CONDITION.

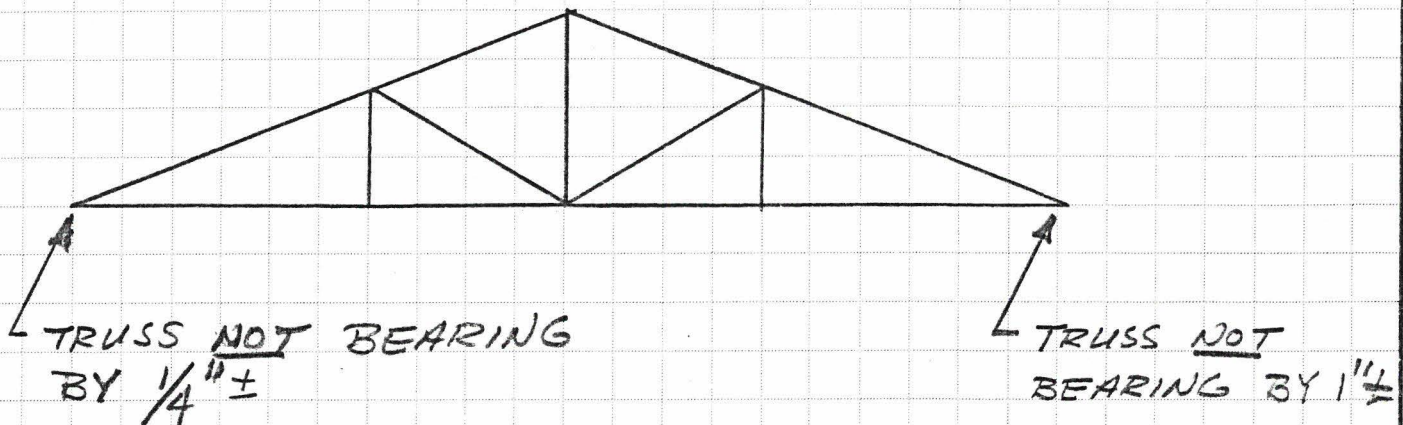
TRUSS RUNNING EAST-WEST ON NORTH SIDE OF DOME

- 1) BOTH COMPRESSION WEBS LOOSE.
- 2) TIMBER APPEARS TO BE IN GOOD CONDITION.

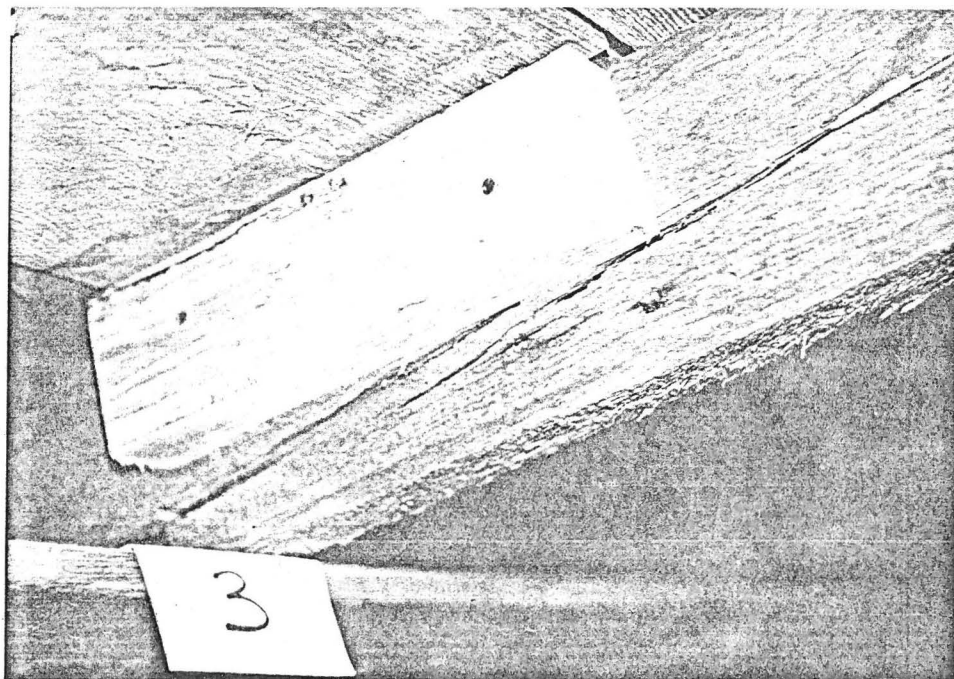
3¹ Roof sloping member badly cracked

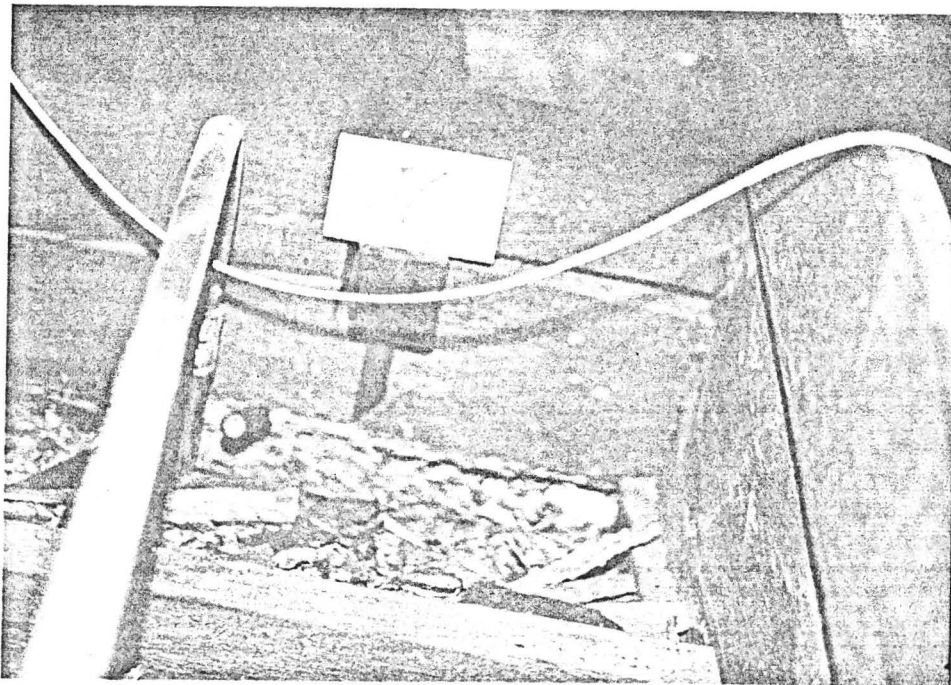
7. Wood rot near eaves

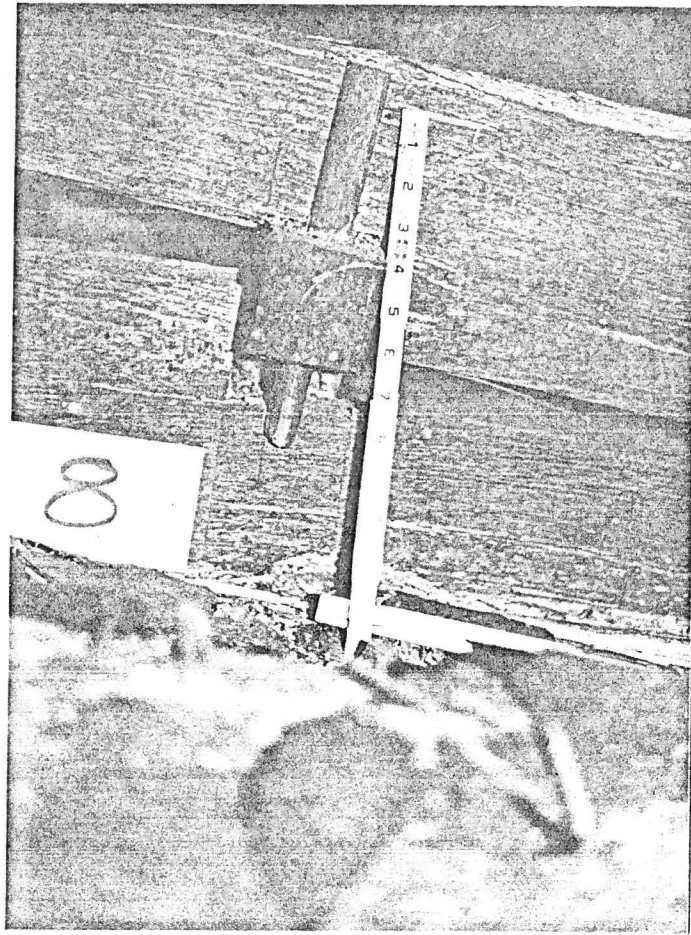
8. Wood rot near eaves

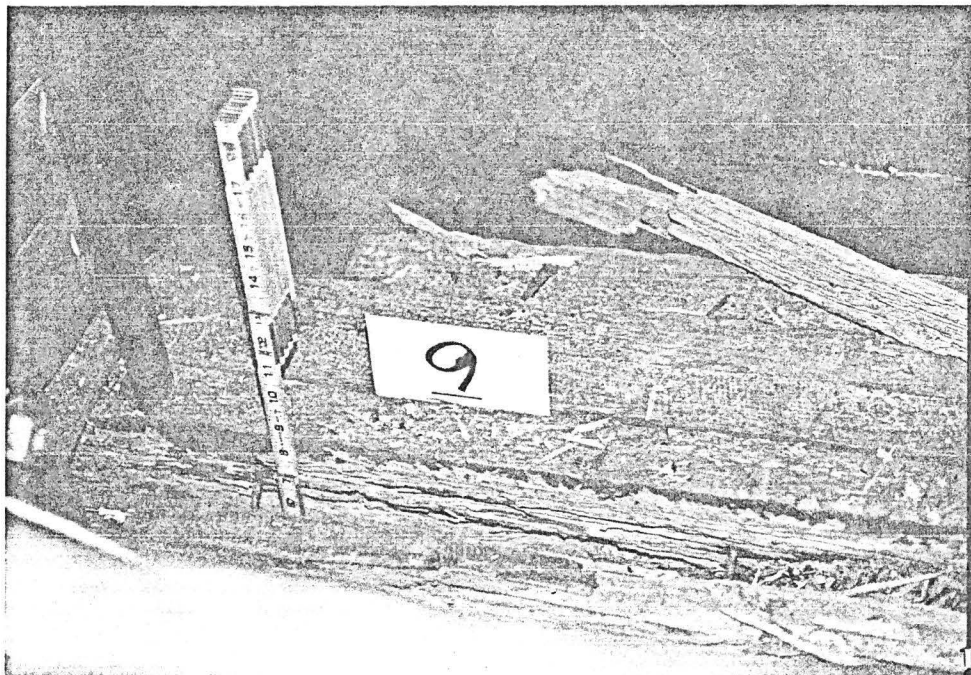
9. W-Truss - top side bot chord - termite damage

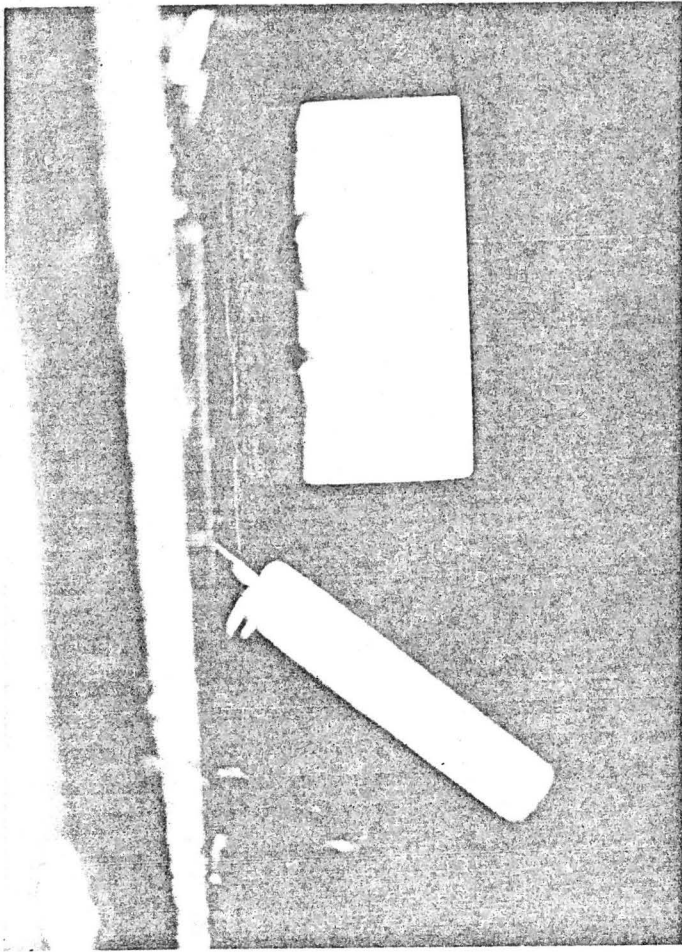
10. W-Truss - bot side bot chord - termite damage

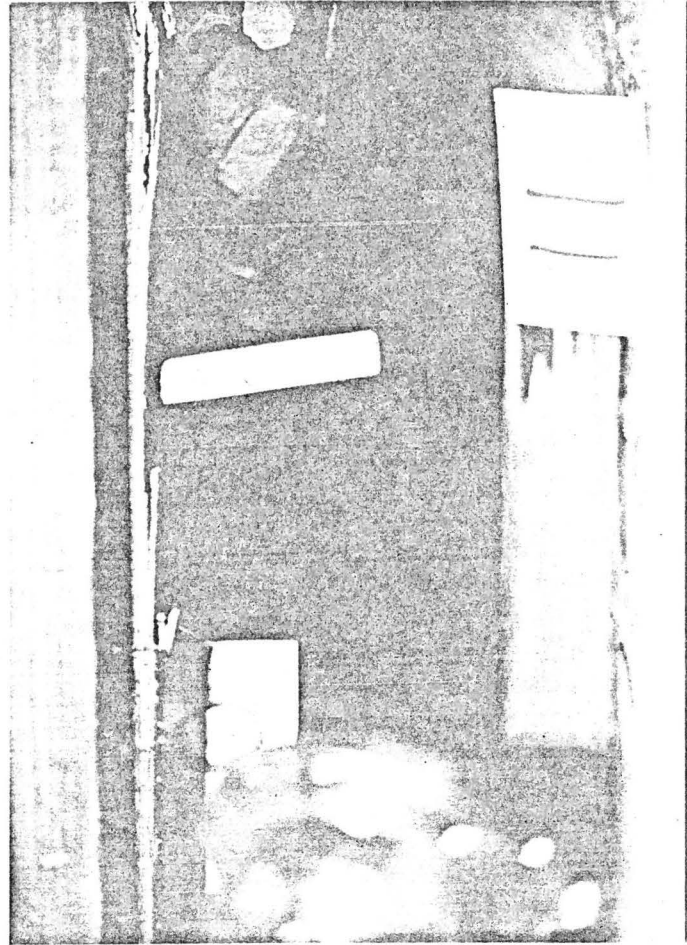
11. W-Truss - bot side bot chord - termite damage

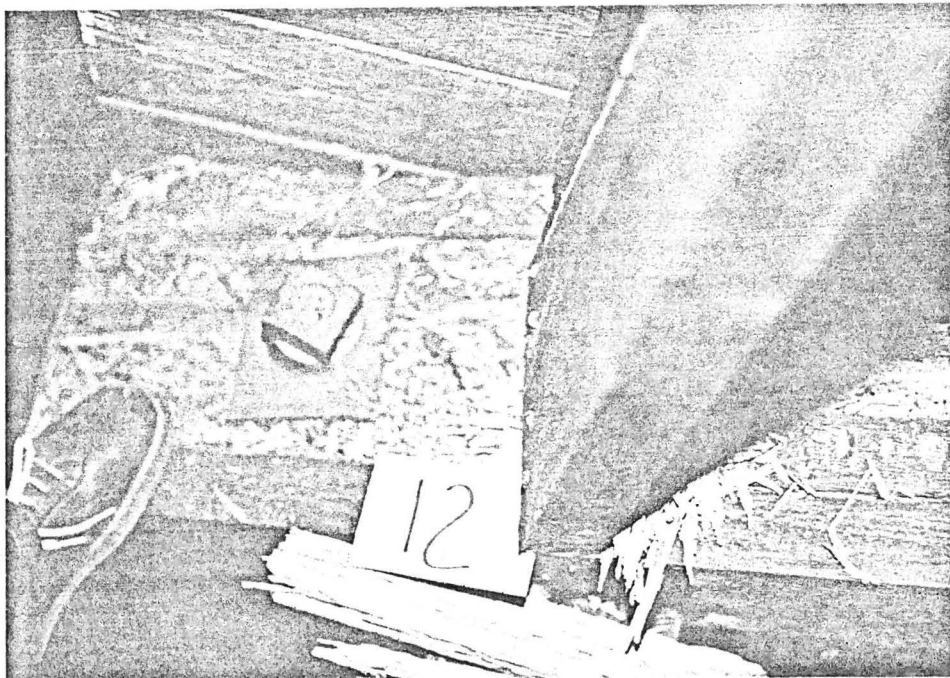
12. W-Truss - top of diagonal chord - termite damage

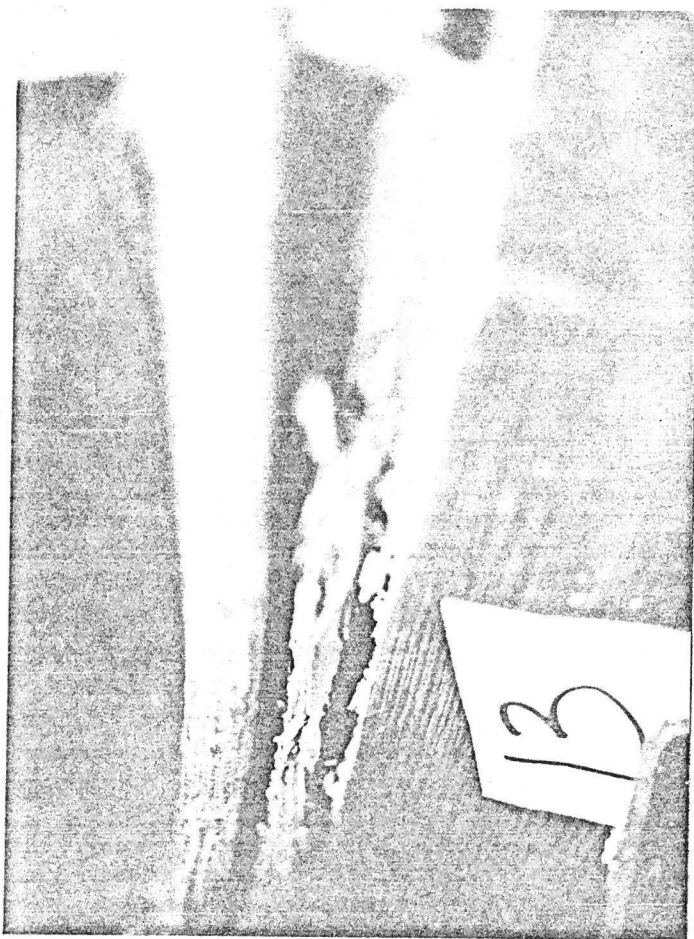
13. 1923 End Truss - top plate termite damage

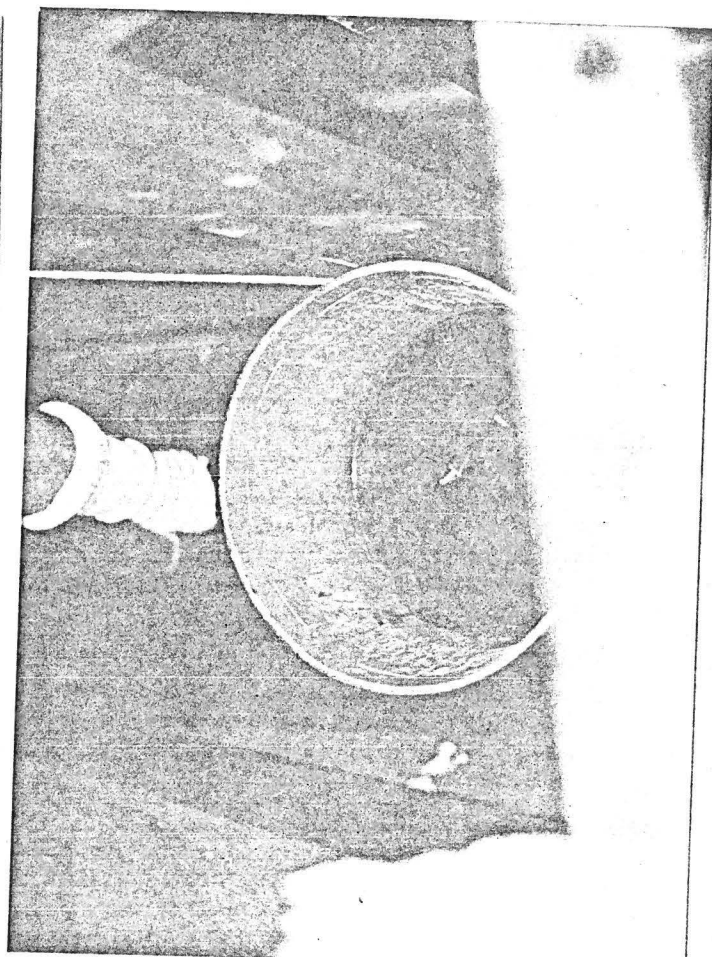
Waste basket with water in it due to a leak - near photo 13

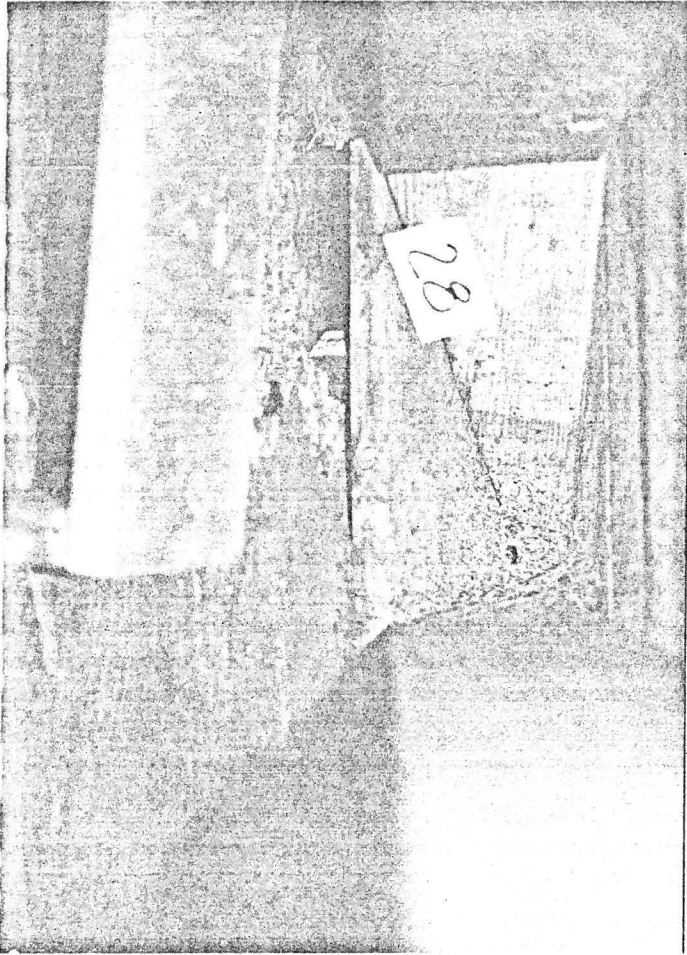
28. Wood rot - near eaves

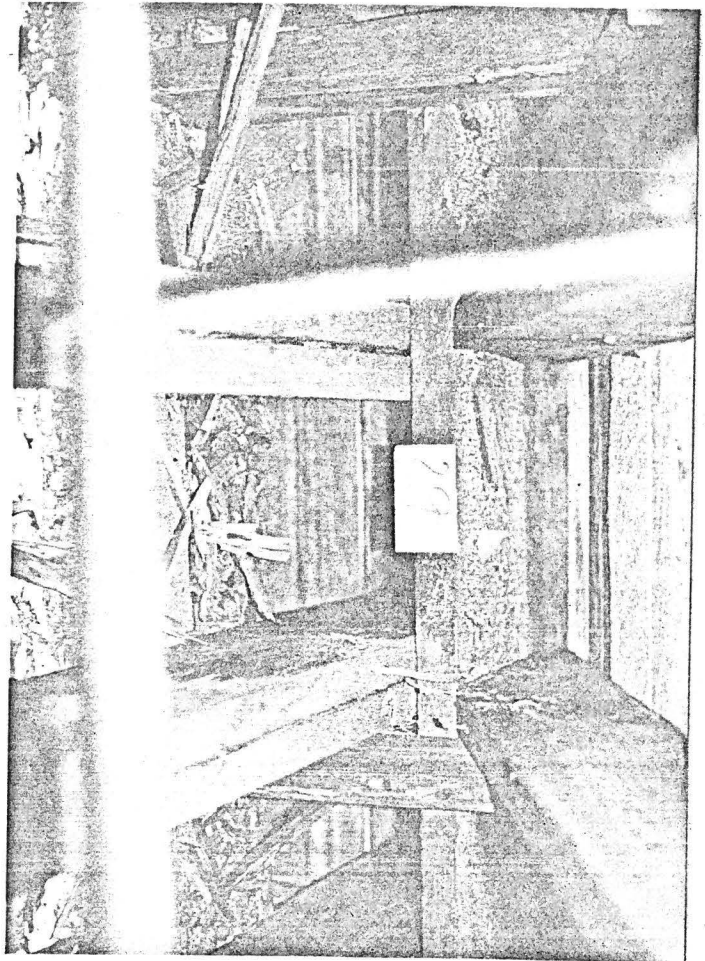
29. Wood rot in top plate - W. side

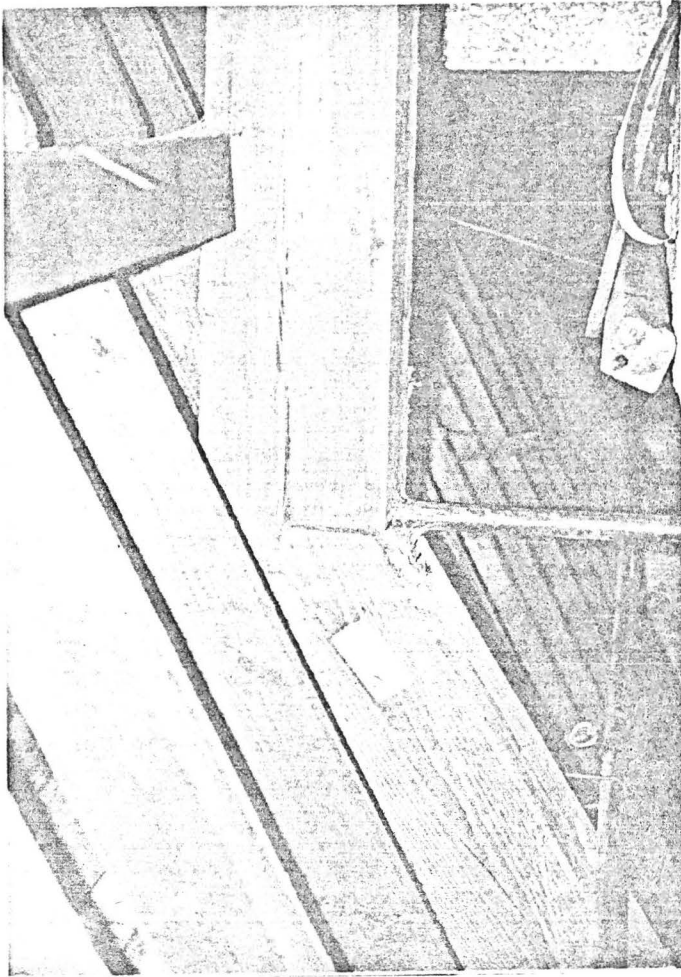
31. NF₃ - N. end - horizontal crack

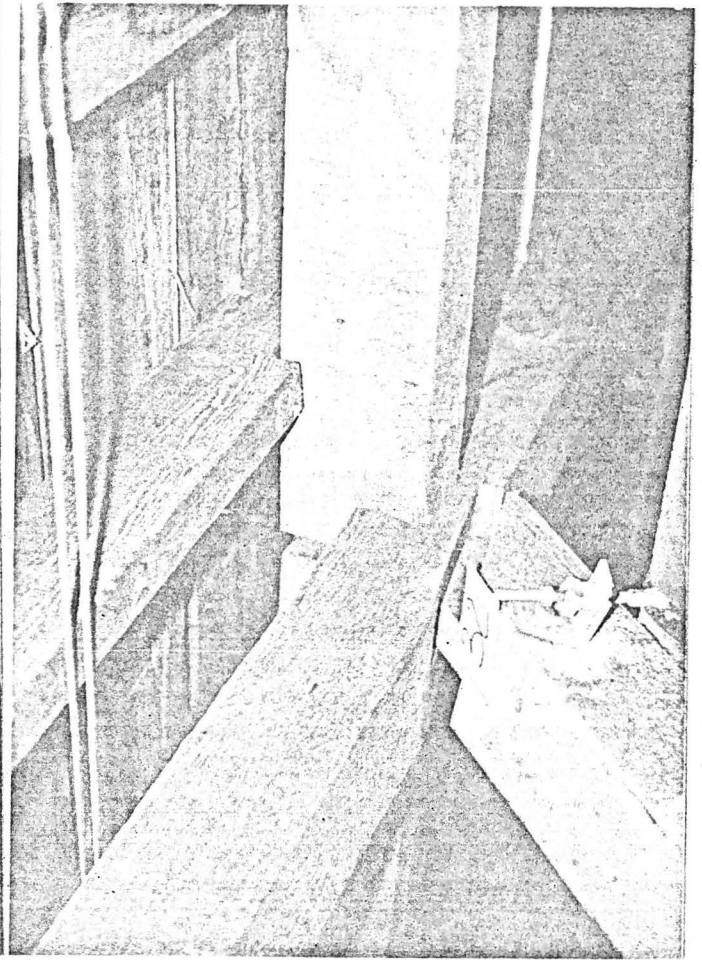
32. Compression diagonal pulling out

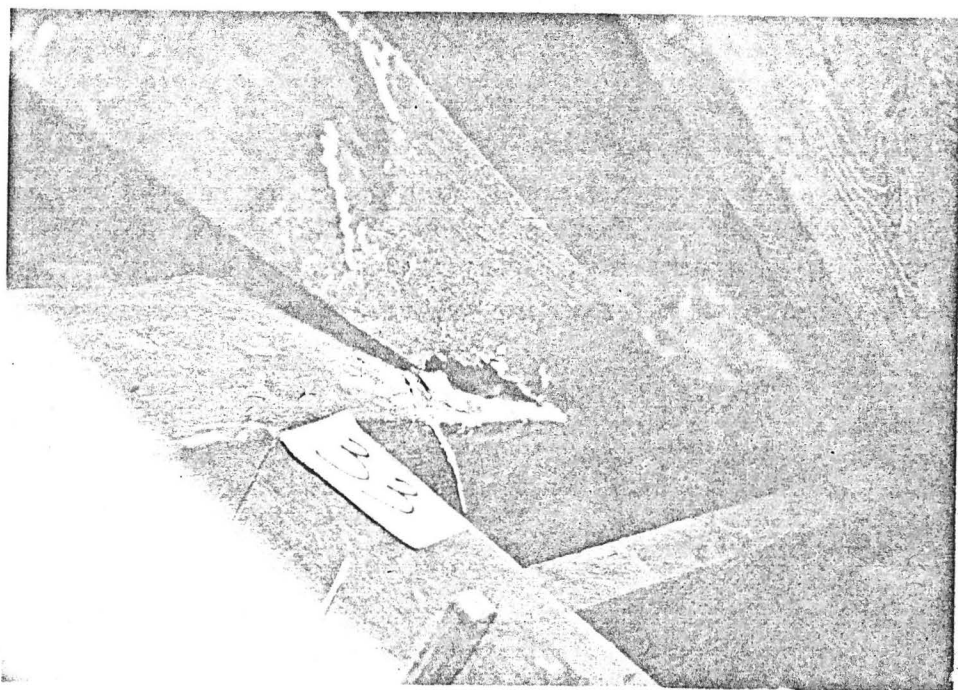
33. Wood rot - lower diagonal and bottom chord

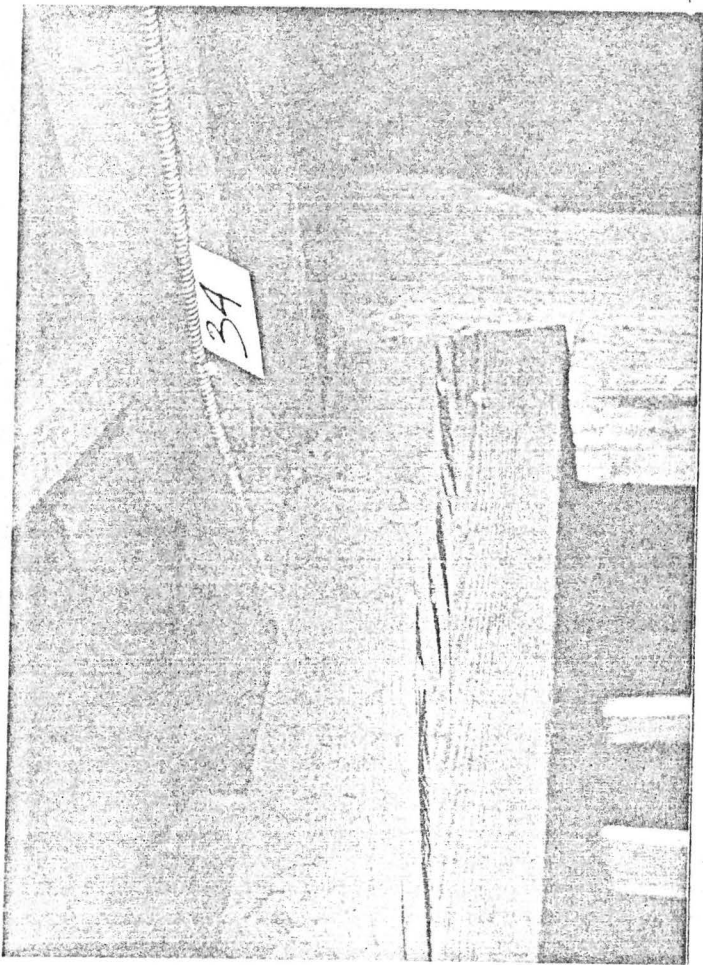
34. Frame S₃ - top chord leaning and cracking

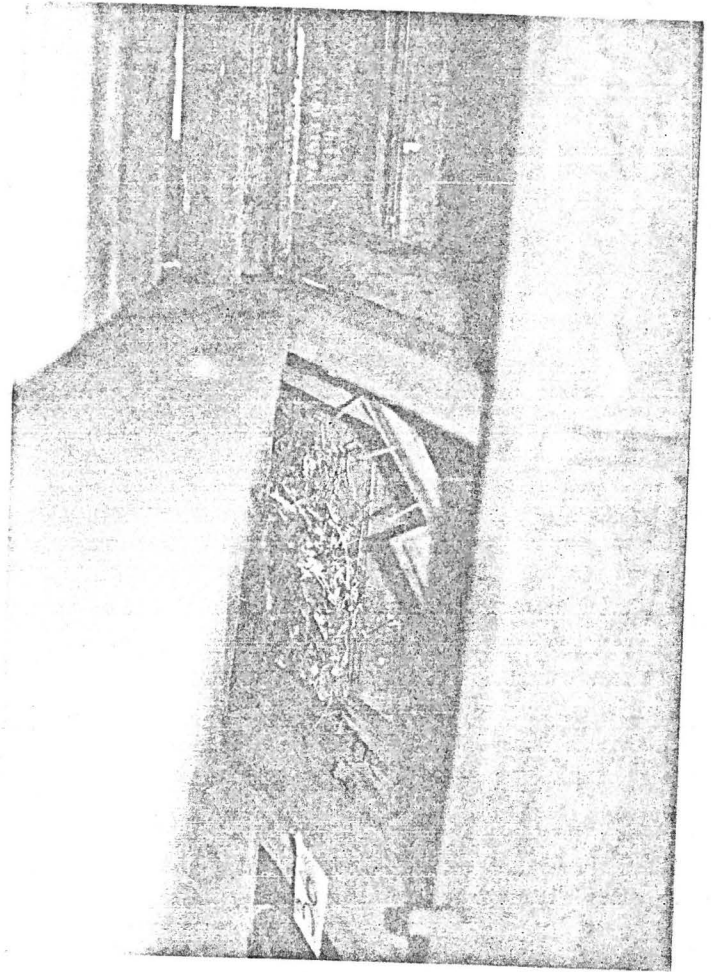
36. Wood rot in horizontal edge member

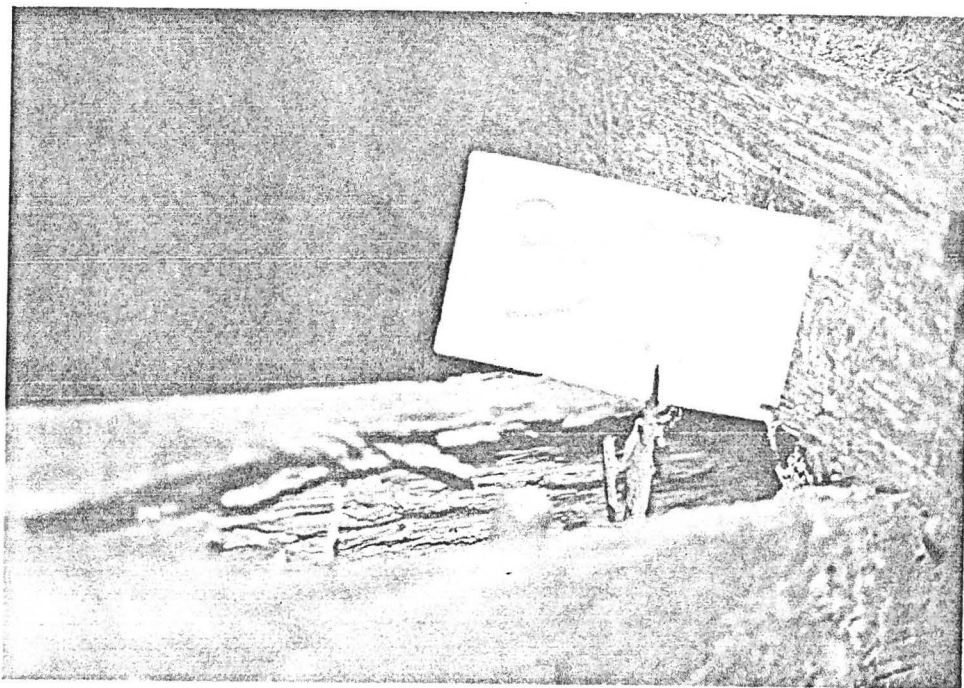
37¹ Wet rot under leak - in top chord South

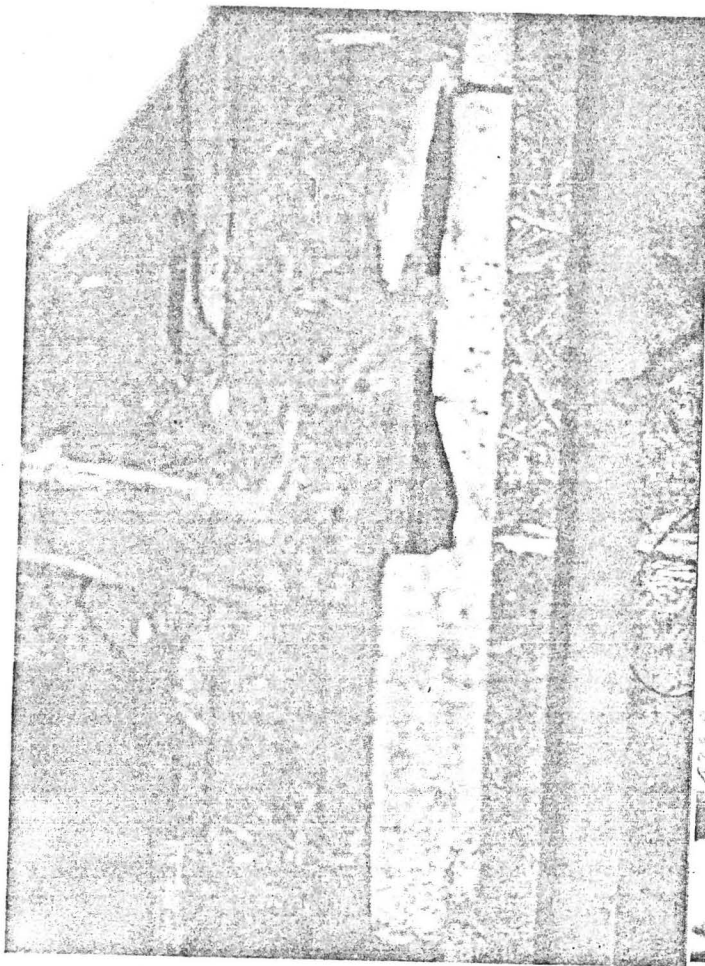
37² Wet rot in top plate below South

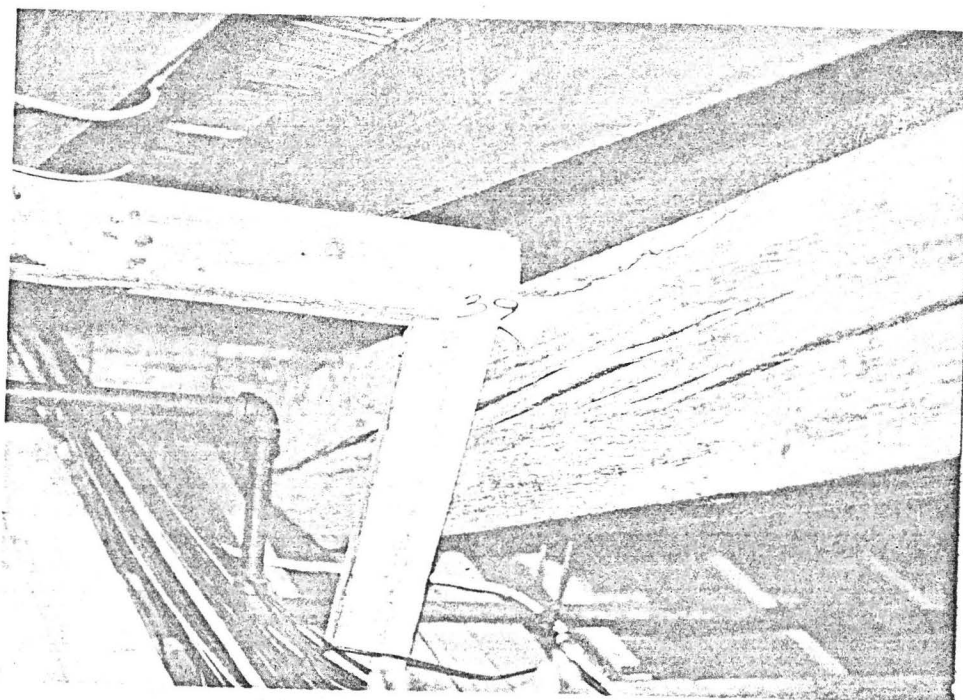
39. Horizontal shear failure and weather checking - NF1

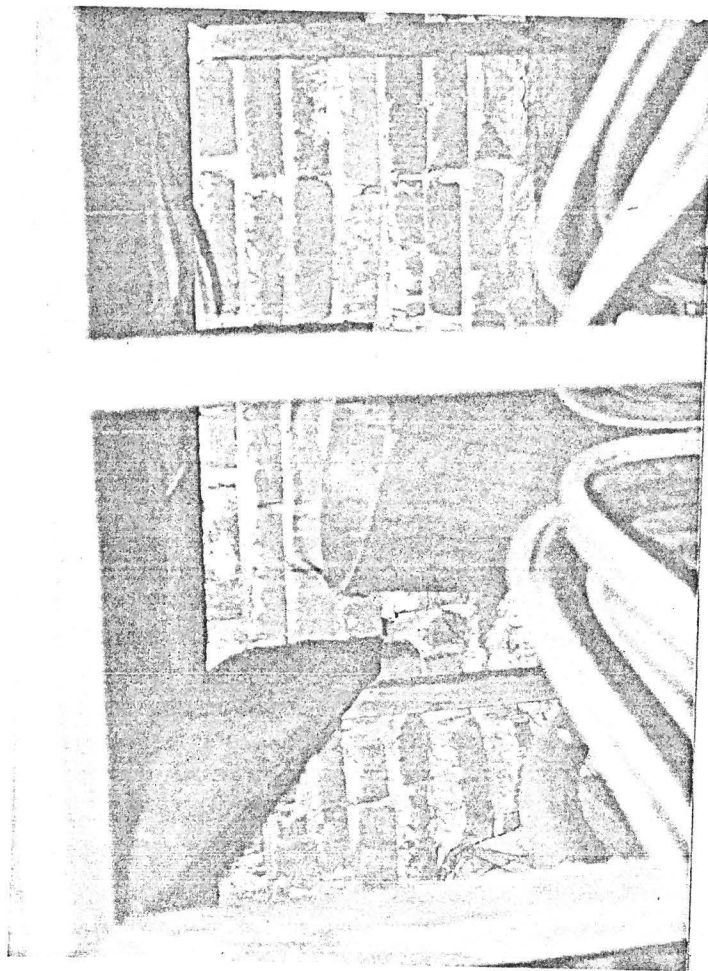
Wet rot in roof South section

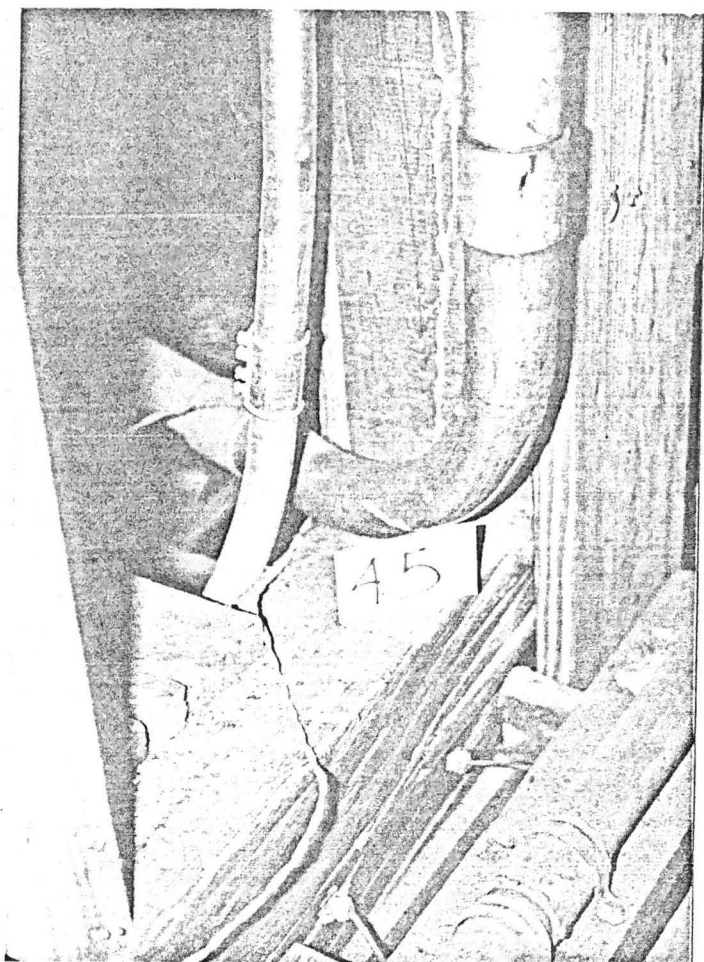
45. Lower joint Frame S₁ - termite and weathering cracks

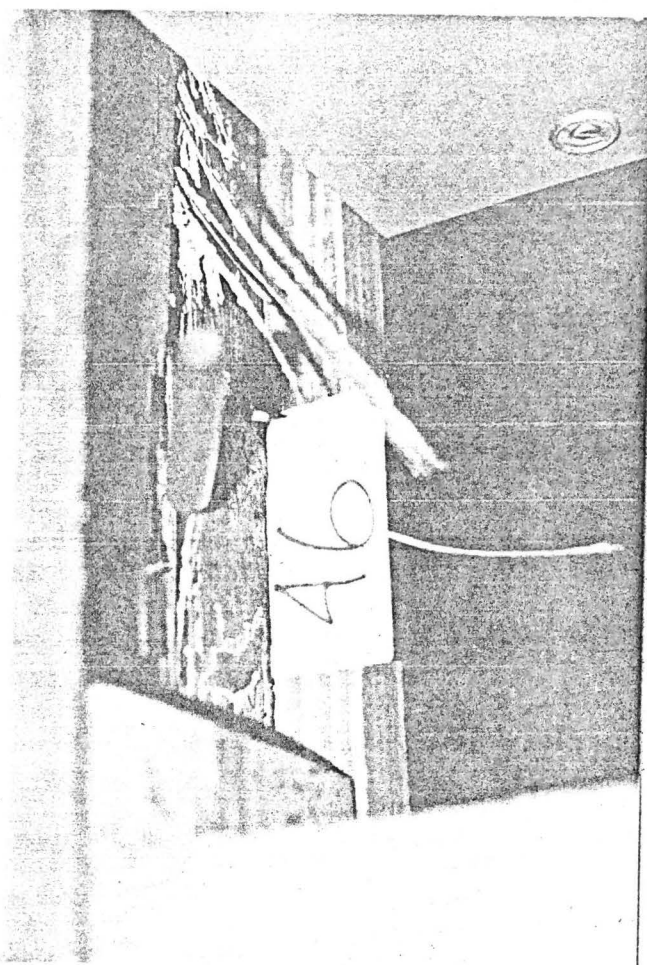
46. Upper joint Frame S₁ - termite and weathering cracks

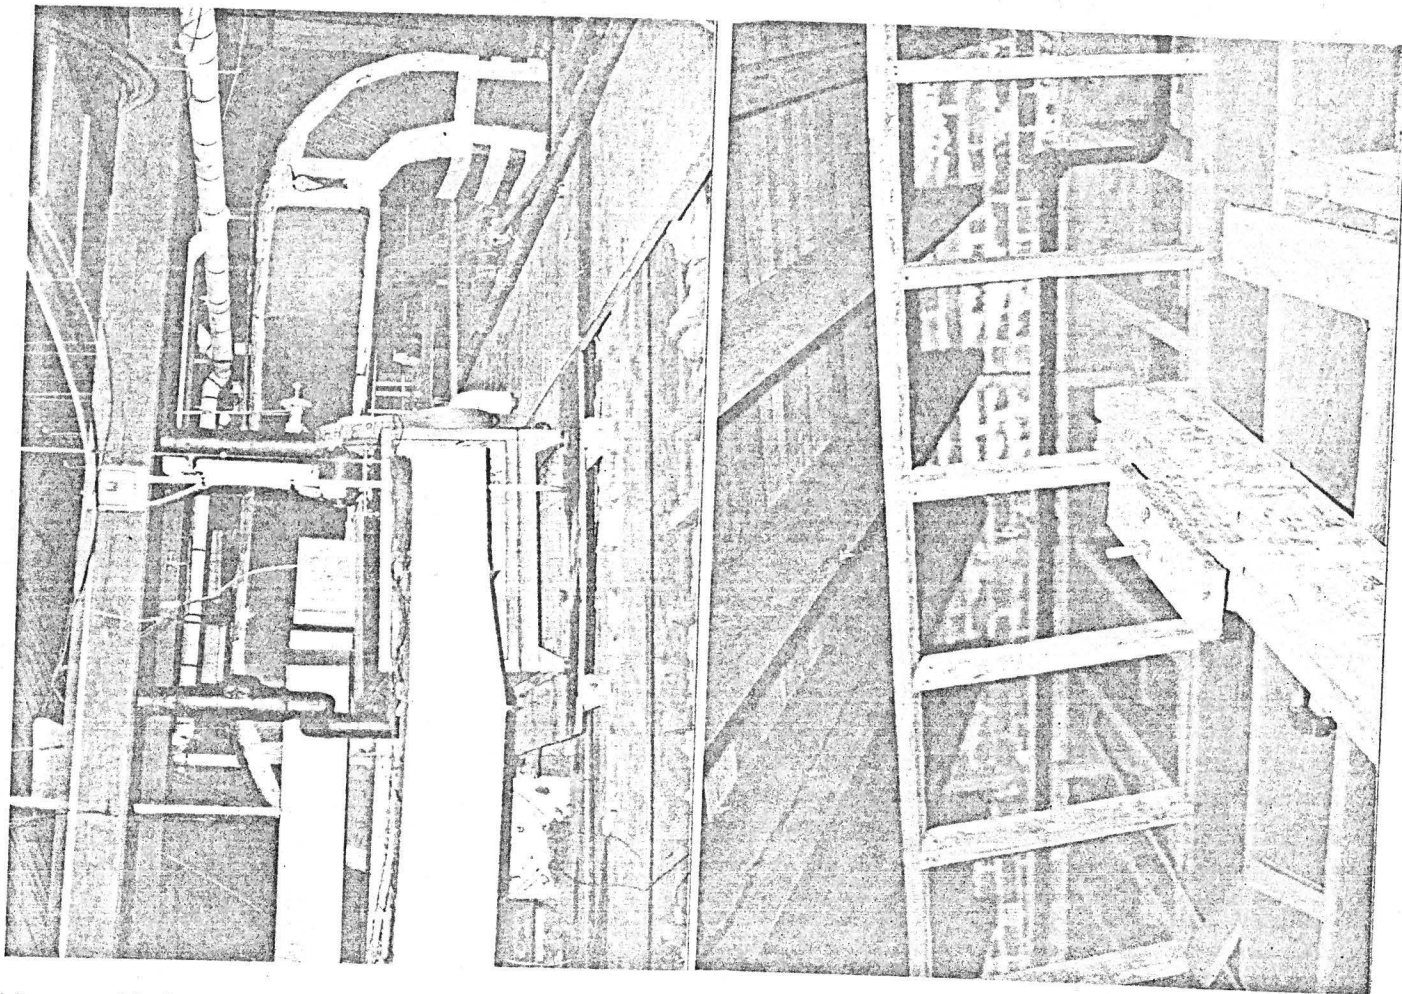
47¹ Air conditioner loading onto bottom
chord Frame S₃

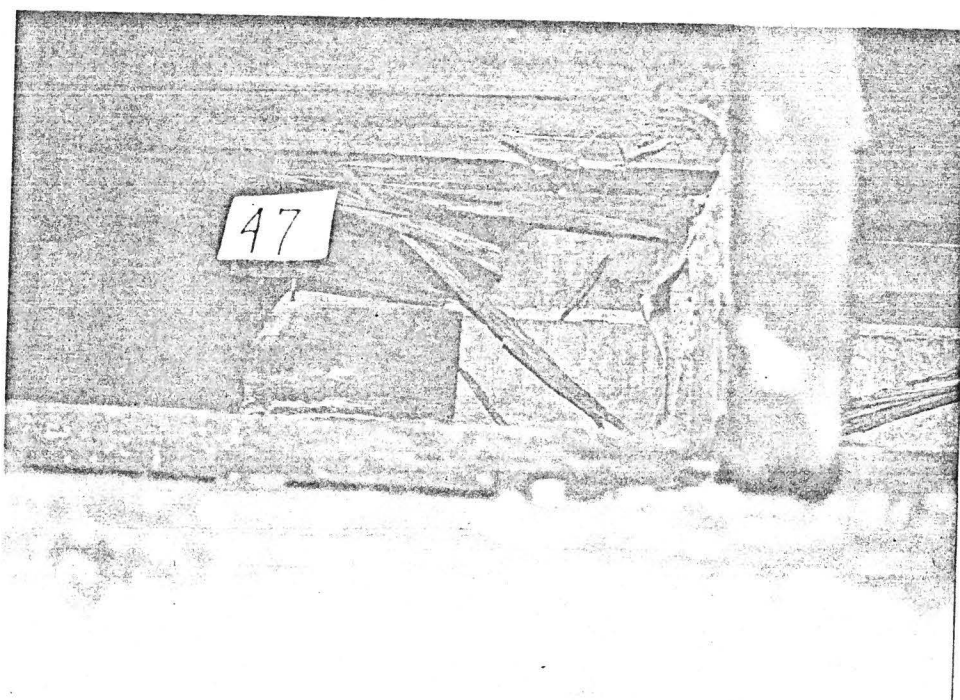
47² Wet rot near base plate of dome
